| BARNWOOD | | |

BARNWOOD

PORCELAIN

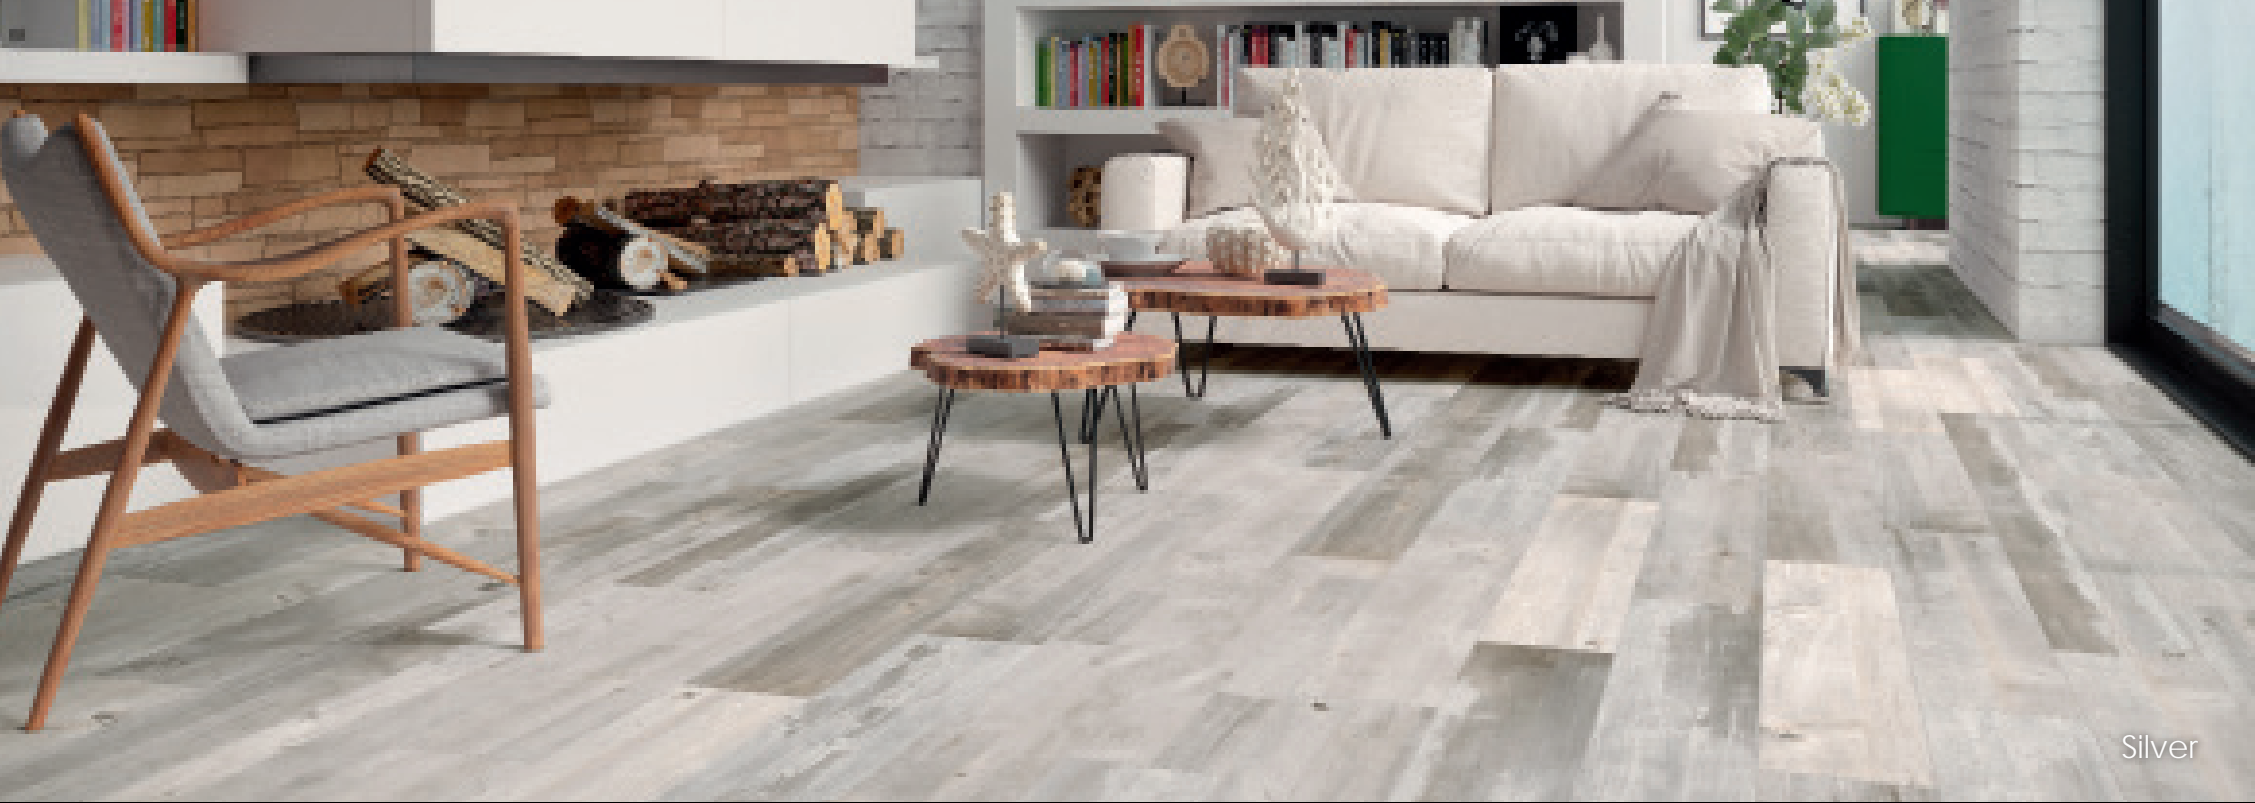
Silver

SILVER

6" x 36"

3" x 18" Bullnose

BRONZE

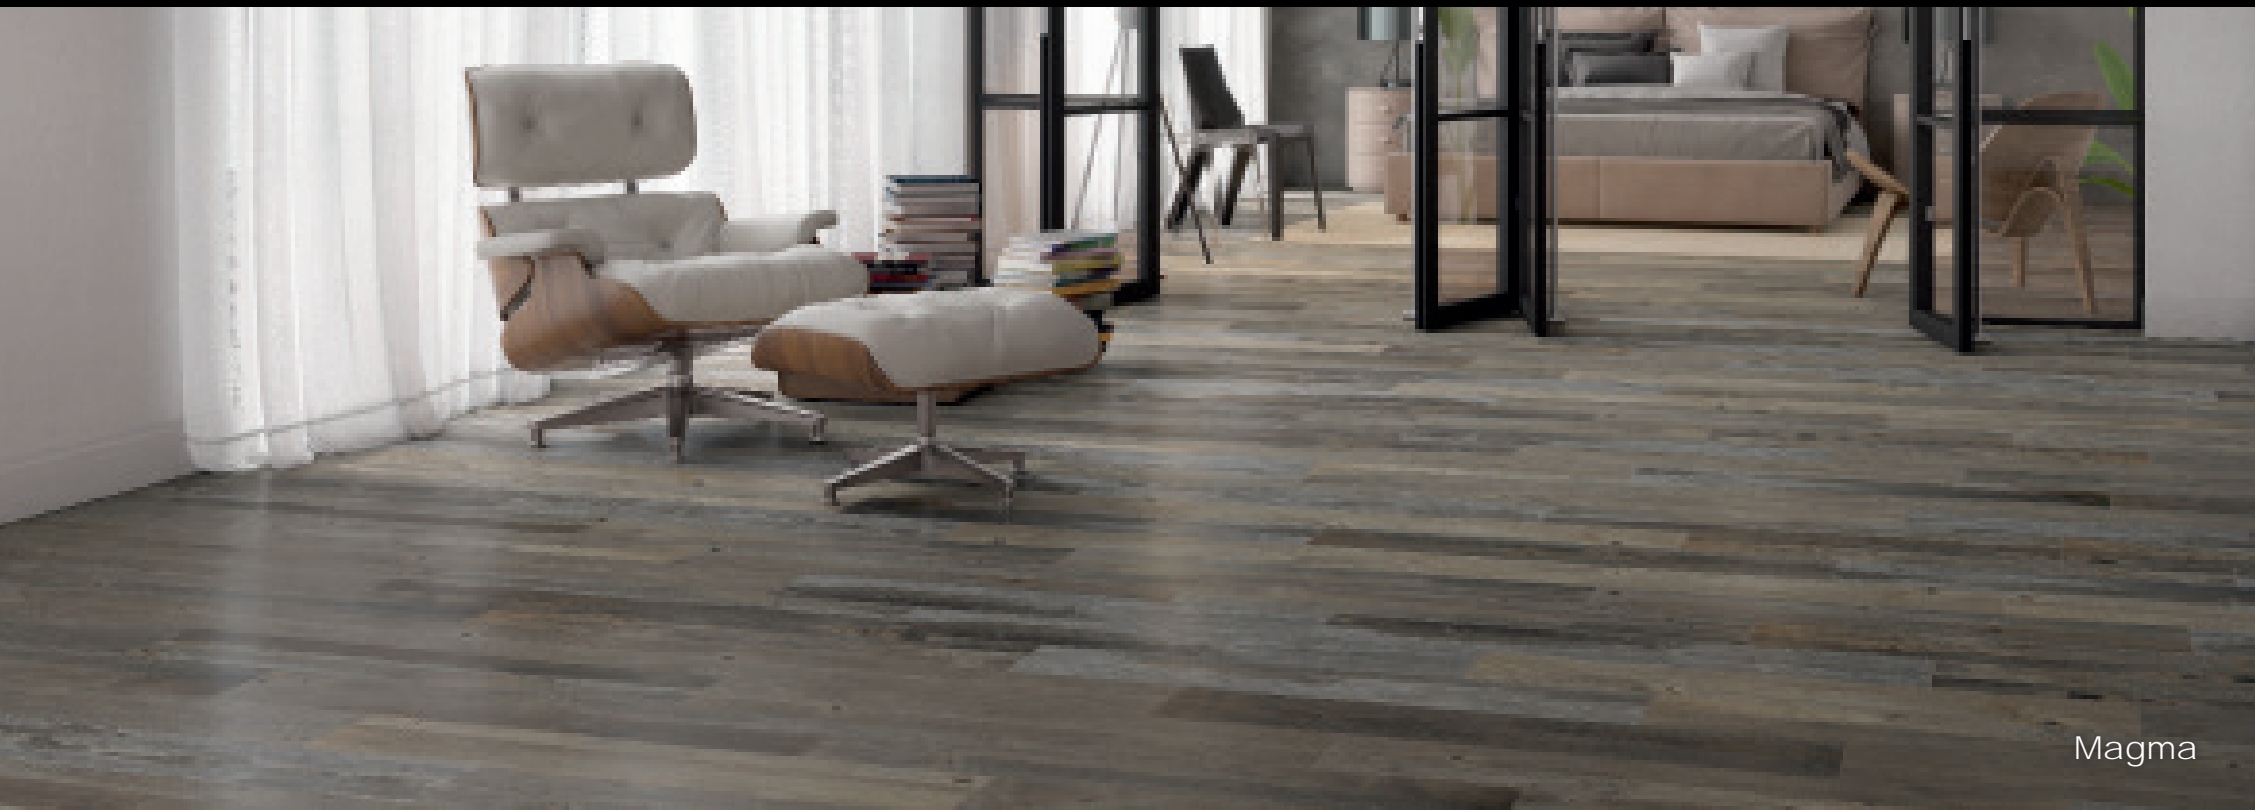
Magma

TILDEN GRAY

6" x 36"

3" x 18" Bullnose

MAGMA
